**CEESEN-BENDER**

**Building intErventions in vulNerable Districts against  
Energy poveRty**

**Deliverable 2.4**

**Synthesis report on demonstration buildings**

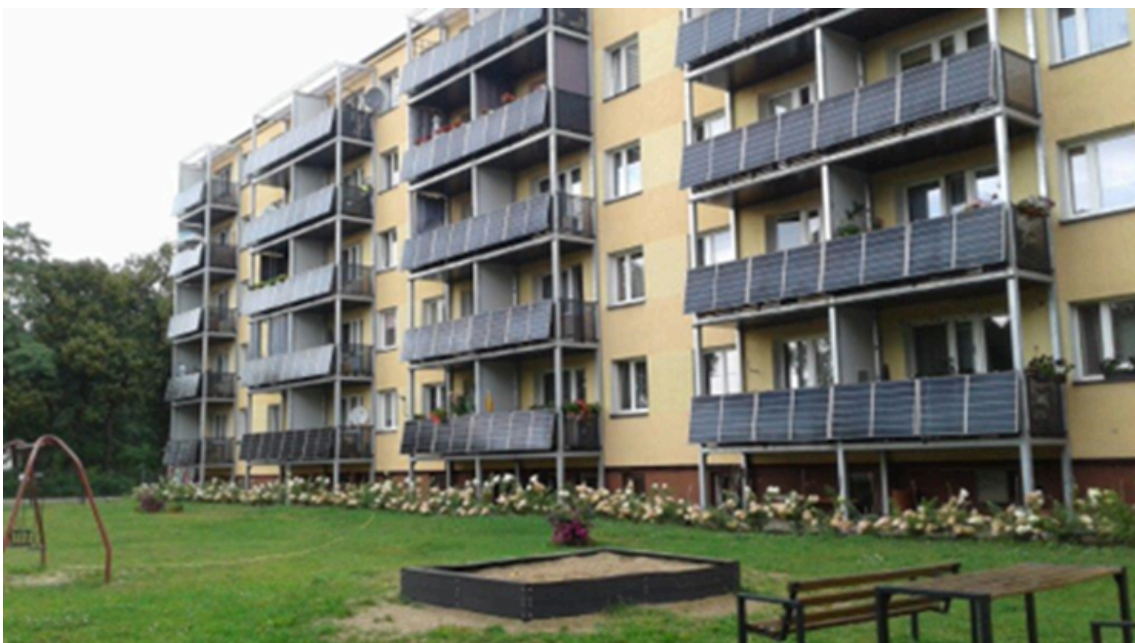
*Figure 1. Demonstration building in Poland.*

The building is located at Śląska 12, in Szczytno Town. Constructed in 1974, the building exhibits a gross floor area of 1 907,52 m<sup>2</sup> distributed across four above-ground floors plus a basement, accommodating 40 apartments with an average area of 46,66 m<sup>2</sup>. The heating system relies on a partially modernized radiator network powered by two NIBE F1345-60 ground-source heat pumps arranged in a cascade configuration with a total capacity of 120 kW. This system is supplemented by a 40 kW photovoltaic (PV) installation. Additionally, the building incorporates multiple energy generation systems: a 40 kW rooftop PV array, vacuum solar panels for domestic hot water (DHW) production, and a further 32 kW PV system mounted on the balcony structures. Annual electricity consumption for DHW is approximately 35 000 kWh, with an average quarterly consumption of around 300 m<sup>3</sup> - equating to roughly 3,75 m<sup>3</sup> per resident

Over the years, the building has undergone a series of renovations that have significantly improved its energy efficiency, thermal insulation, and overall safety. In 2005, a complete renovation of the stairwells, including the replacement of entrance doors and windows, was undertaken. This was followed in 2006 by a roof renovation that incorporated insulation for the roof-ceiling assembly, financed by a 60 000 PLN (13 954 EUR) loan. A major thermal modernization project was carried out between 2008 and 2009, during which vestibules were constructed 80% of the windows and balcony doors were replaced, and balcony renovations were completed with financial support from a 100 000 PLN (23 256 EUR). In 2010, the electrical installations in the basement and common areas were upgraded to a 24V system, and the horizontal water supply network was replaced, including the installation of a limescale removal device that not only improved drinking water quality but also extended the lifespan of heating elements by approximately 80%. Further external improvements were made in 2011 with the construction of sidewalks and a parking lot featuring a stormwater drainage system, an initiative that was self-financed at a cost of 70 000 PLN (16 279 EUR).

The integration of renewable energy sources was significantly advanced in 2014 with the installation of a 40 kW PV system on the building's roof and the deployment of the ground-source heat pumps. In 2016, the building's cold water supply risers were replaced, and a radio water meter reading system was installed, a project self-financed with 25 000 PLN (5 814 EUR). The DHW system was further enhanced in 2017 by incorporating renewable energy sources through air-water heat pumps and

additional solar installations. In 2022, attached balconies were constructed and an extra 32 kW PV system was installed on the balcony structures to support DHW heating. Most recently, in 2024 a rainwater drainage system was constructed to channel roof runoff into a retention tank for irrigating the green areas in front of the community building, with part of this project financed through a 10% loan forgiveness mechanism from earlier funding.

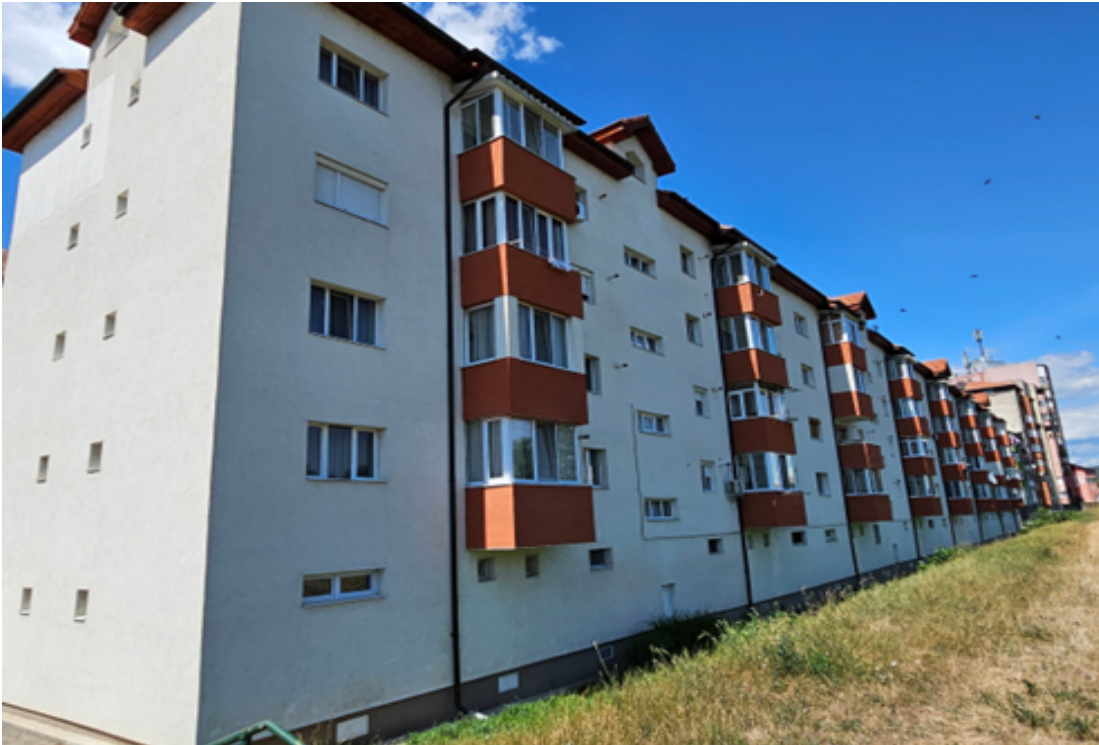
*Figure 2. Demonstration building in Romania.*

Constructed in 1978, the residential building located at Livezii 49, Alba Iulia Municipality, Romania, has a gross building area of 5 215 m<sup>2</sup> and a conditioned floor area of 4 518 m<sup>2</sup>. It consists of four above-ground floors and accommodates 64 apartments, each with an average heated area of 70,59 m<sup>2</sup>. The conditioned volume of the building is 11 749 m<sup>3</sup>.

The renovation primarily focused on thermal insulation measures, including roof and attic insulation, external wall insulation, replacement of exterior windows, balcony

doors, and entrance doors with thermopane units, as well as waterproofing of the foundation and standard facade painting. These interventions significantly improved the building's energy performance, leading to enhanced thermal comfort, reduced heating costs, improved noise insulation, and lower indoor humidity levels, contributing to better air quality and a reduction in mold formation.

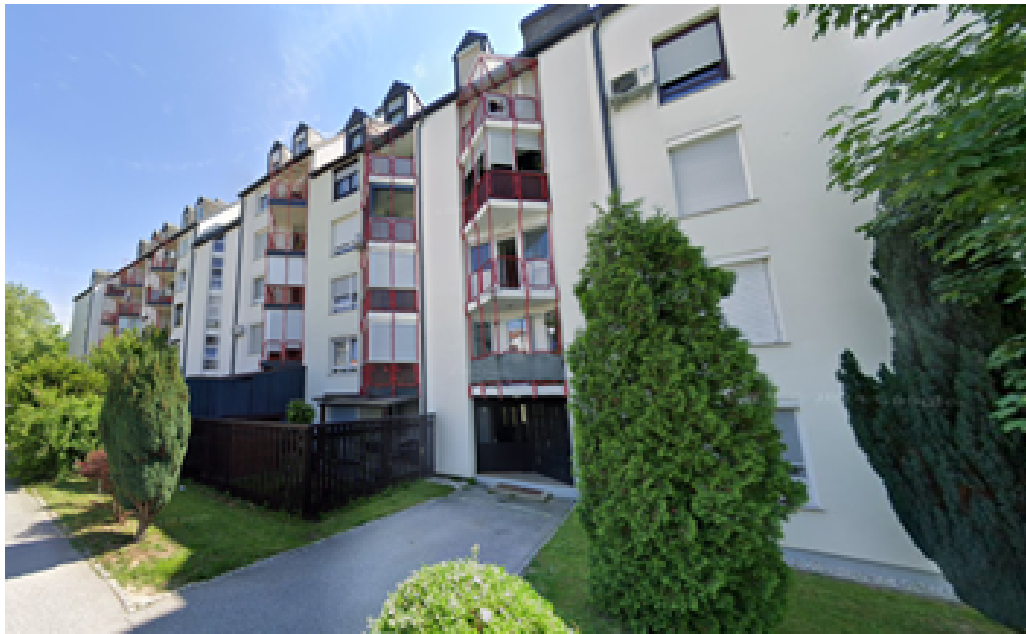
*Figure 3. Demonstration building in Slovenia.*

Constructed in 1989, the residential building is located at Ulica 25. maja 15, 17, 19 in Ptuj Municipality, Slovenia. The building encompasses a gross area of 5 798.2 m<sup>2</sup> distributed over eight floors, accommodating a total of 64 apartments with an average unit size of approximately 56,8 m<sup>2</sup>. It is integrated into a district heating network that utilises a combination of wood biomass and natural gas.

In terms of renovation, the building underwent targeted interventions aimed at enhancing its thermal performance. The construction measures focused primarily on

the thermal insulation of the exterior walls and the replacement of windows and doors, actions that are expected to yield substantial energy savings. These upgrades lead to a reduction in energy consumption and associated costs while simultaneously enhancing indoor thermal comfort and overall living conditions, thereby resulting in additional health benefits through enhanced protection against external temperature fluctuations and noise.

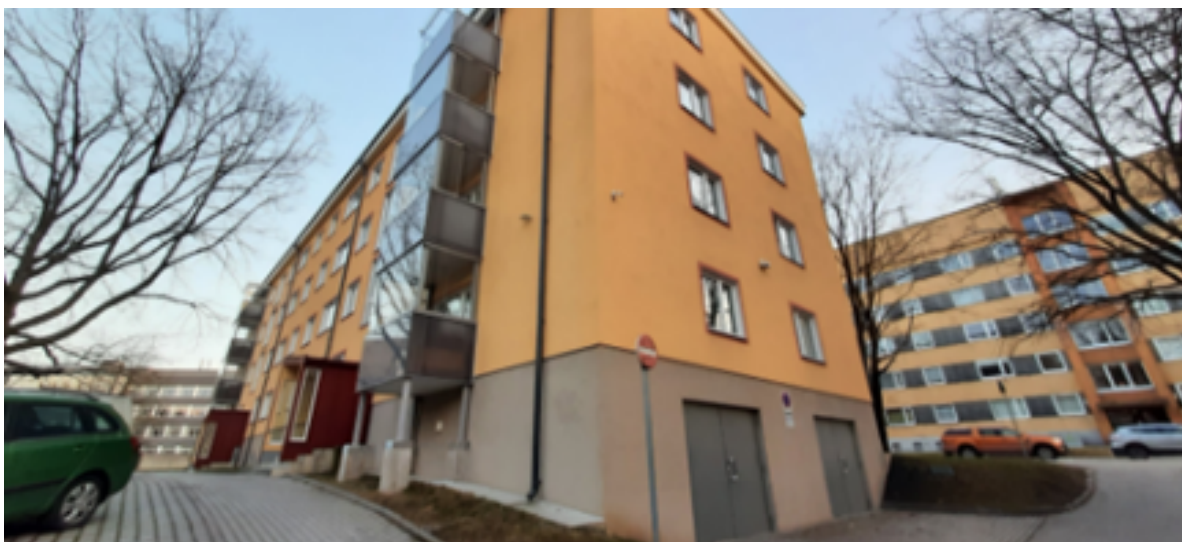
*Figure 4. Demonstration building in Estonia.*

The multi-apartment residential building located at Tähe 2 in Tartu City, Estonia, was originally constructed in 1964. It consists of 32 privately owned apartments, with a total gross building area of 1 776.4 m<sup>2</sup>, of which 1 440 m<sup>2</sup> constitutes heated space. The structure spans four floors and has an average apartment size of 42,3 m<sup>2</sup>.

The building is connected to a district heating network, which supplies both space heating and DHW. The energy carrier for heating is primarily biomass (over 90%), while natural gas is utilized for cooking. Electricity consumption is offset by an on-site PV system, which partially covers the building's energy demand and feeds excess electricity back into the grid. Prior to renovation, space heating relied entirely on district heating, consuming 289 MWh per year, while water heating and cooking were

supported by natural gas (32,6 MWh per year) and overall electricity consumption amounted to 38,7 MWh per year. Post-renovation, space heating consumption was reduced to 105 MWh per year, water heating to 35 MWh per year, and natural gas usage dropped significantly to 5,2 MWh per year. Electricity consumption remained relatively stable at 40,2 MWh per year, with PV generation contributing 27,5 MWh annually, of which 19,3 MWh was fed into the grid.

Energy efficiency improvements were substantial, elevating the building's classification from an F-class (pre-renovation energy efficiency index of 257 kWh/m<sup>2</sup> per year) to an A-class (post-renovation index of 74 kWh/m<sup>2</sup> per year). The primary renovation measures included a full building envelope upgrade, incorporating insulation of external walls, roof, and first-floor flooring, as well as the complete replacement of all doors and windows. These interventions resulted in an energy performance certificate (EPC) based energy consumption reduction of 68%, with a 36% decrease in district heating demand, a marginal 1% reduction in electricity usage, and an 84% drop in natural gas consumption.

Mechanical engineering enhancements included the transition of DHW heating from natural gas to district heating and the implementation of centralized heating controls. Each apartment is now equipped with a central control unit, allowing room-based temperature regulation through radiator thermostats and control and monitor ventilation system. Building was equipped with a demand-based (CO<sub>2</sub>) heat recovery ventilation system, which adjusts airflow of the main unit and also regulates the apartment's VAV (Variable Air Volume) dampers according to occupancy needs. Electrical system upgrades included the installation of a PV plant and comprehensive modernization of the building's electrical infrastructure.

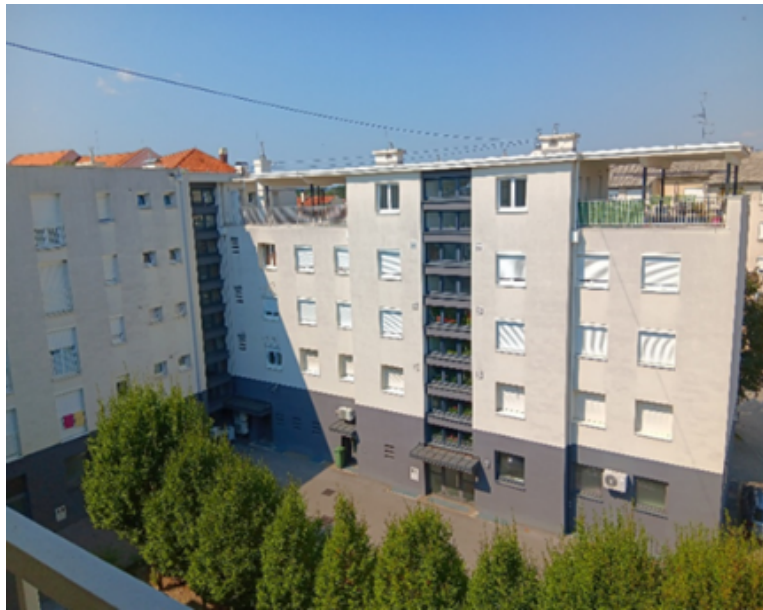
*Figure 5. Demonstration building in Croatia.*

The residential building located at Uska 1 in Čakovec Town, Croatia, is a multi-apartment structure built in 1970. It comprises a total gross construction area of 4 134,49 m<sup>2</sup>, with 2 635,81 m<sup>2</sup> dedicated to residential use. The building consists of three floors and includes 49 apartments, with an additional eight business premises. Each apartment has an average area of approximately 57 m<sup>2</sup>. The ownership structure is entirely private, with no public ownership.

The renovation process focused primarily on improving the thermal envelope of the building. Key construction measures included the installation of thermal insulation on the outer walls, roof, floor, and ceiling, as well as the complete replacement of external carpentry. These interventions aimed to reduce heat loss, improve indoor thermal comfort, and generate substantial energy savings.

Electrotechnical measures consisted of the replacement of indoor lighting systems to improve energy efficiency further. However, no mechanical engineering interventions, such as heat pump installations or DHW heat collectors, were implemented. Financial
